Q235B 钢含硫污水罐的腐蚀开裂失效分析

Stress Corrosion Cracking Failure of Q235B Steel Used for Sulfur-containing Waste Water Tank

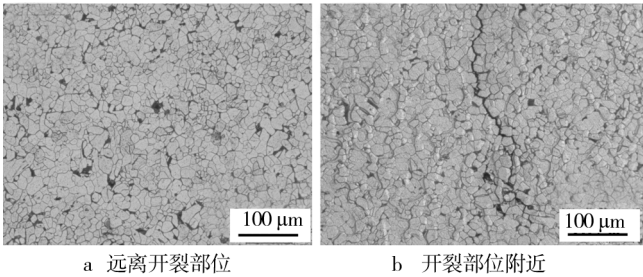
在原料水罐远离开裂部位及开裂部位分别切割取样并进行金相显微组织观察,形貌如图 1 所示。可以看出,原料水罐的金相组织为铁素体加少量珠光体,在开裂部位附近还存在微观裂纹,且裂纹沿着晶界发展,裂纹发展末端出现分叉特征。根据裂纹的微观形貌可以判断该裂纹为沿晶型应力腐蚀裂纹^[4-5],同时也可以排除发生晶间腐蚀的可能^[6]。

图 1 金相显微组织
Fig.1 Metallographic structure: a) the site far away from the cracks,b) the site near the cracks

由水罐闭塞区域发生腐蚀的反应机理可以看出,电化学反应产生的氢原子一部分渗入到基体内,另一部分形成氢分子溢出。然而在基体表面不但覆盖有涂层,还有阳极溶解产生的腐蚀产物。这两层阻隔作用大大减少了 H_2 的溢出,大部分氢原子渗入到基体内。在基体内晶界界面上存在大量的位错,使得氢原子在基体中的扩散相对容易,所以氢原子大部分积聚在晶界上并结合成氢分子,最终形成氢鼓泡 (HB) 和微裂纹^[12]。这与图 1 中观察到的沿晶型裂纹一致。

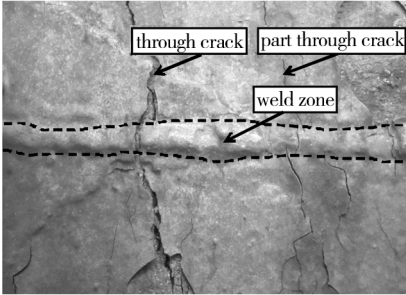
原料水罐开裂部分的宏观形貌如图 2 所示,裂纹萌生于水罐内壁,并在垂直方向优先发展,裂纹通过

扩展和聚合形成大裂缝,最终穿透壁厚导致泄漏。同时在裂缝周围还发现大量的未穿透裂纹。裂缝方向与焊缝方向垂直,可以排除焊缝热影响区导致的开裂^[7]。由图 2 还可以看出,裂纹扩展过程中具有分叉结构,这是明显的应力腐蚀裂纹的特征。

图 2 原料水罐开裂部位的宏观形貌

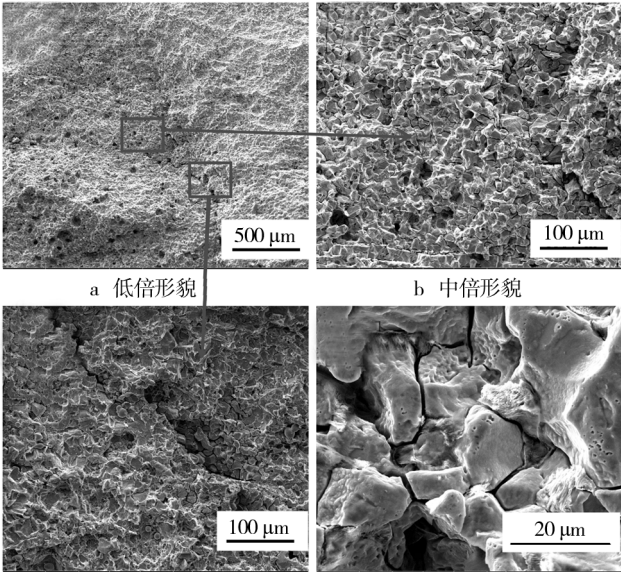
裂缝断面的微观形貌有助于判断开裂过程的特征,对分析开裂原因起到关键作用。截取的断面试样经过处理后进行 SEM 观察,其断面微观形貌均一致。图 3a 是其中一个裂缝断面的断口形貌放大图,断口凹凸不平,并且有一部分区域分布着大小不一的小孔洞。对该区域进行再一次放大观察,其结果如图 3b 和图 3c 所示,裂缝断面微观形貌呈现沿晶型应力开裂特征。将视场移至中部,发现有一条沿晶型扩展的二次裂纹,如图 3d 所示。

Fig.3 SEM micro-morphology of the fracture :a) low magnification,b) medium magnification,c) high magnification,d) secondary crack

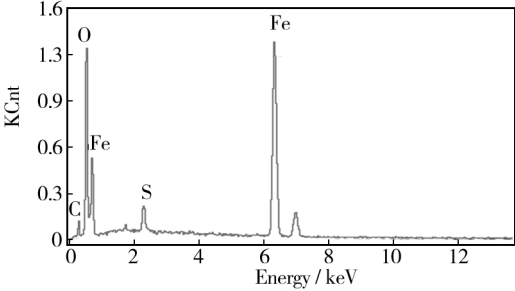
由于穿透裂纹的断口在环境中存在时间比较长,其表面的腐蚀产物已经不能说明开裂原因,而未穿透裂纹及二次裂纹经打磨后仍能保留开裂腐蚀时的产物。为了能够辅助分析其开裂机制,对二次裂纹部位的腐蚀产物进行成分分析。对图 1b 裂纹中填充的黑色物质进行 EDS 能谱分析,如图 4 所示。腐蚀产物元素成分(以质量分数计)为:C 4.68%,O 19.70%,S 2.57%,Fe 73.05%。

图 4 未穿透裂纹内部腐蚀产物的 EDS 能谱分析

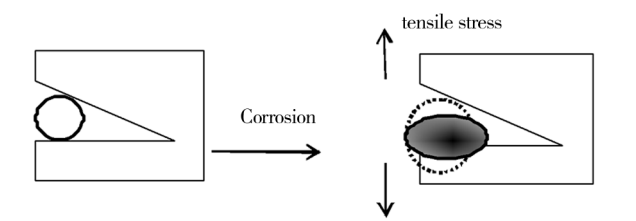
由以上讨论可知,氢分子在晶界内部的积聚,必然形成一定的拉应力,这是发生应力腐蚀的必要条件。同时,在发生电化学腐蚀时形成的腐蚀产物与被腐蚀基体的体积膨胀也是不可忽视的应力来源^[13]。为了计算腐蚀产物诱发应力大小,建立腐蚀产物诱发应力模型,如图 5 所示,该模型满足以下条件:1) 被腐蚀基体和腐蚀产物均为球形,并且腐蚀发生在楔形裂纹中;2) 不同腐蚀产物之间均为机械混合。

图 5 腐蚀产物诱发应力模型

根据虎克定律,其应变造成的拉应力不可忽视。如果发生在楔形裂纹中,拉应力在裂纹尖端还会导致应力集中,加剧微裂纹的扩展和断裂。研究发现,16Mn 碳钢等在预拉应变量达到 2% ~ 3% 左右时发生断裂^[14]。由此可知,应变量达到 36% 时,其造成的应力将大大提高其应力腐蚀敏感性,并促进微裂纹的扩展和断裂。此外,本失效分析并未排除原料水罐失效部位存在结构拉应力及其应力水平,如果其存在,会对开裂失效过程产生促进和协同作用^[15]。
