某天然气管道内腐蚀原因及防控措施

Corrosion Reasons and Control Measures of a Natural Gas Pipeline

为了弄清AB段更换管段内表面发生的腐蚀类型、腐蚀产物下蚀坑的发展方式以及蚀坑形貌等,收

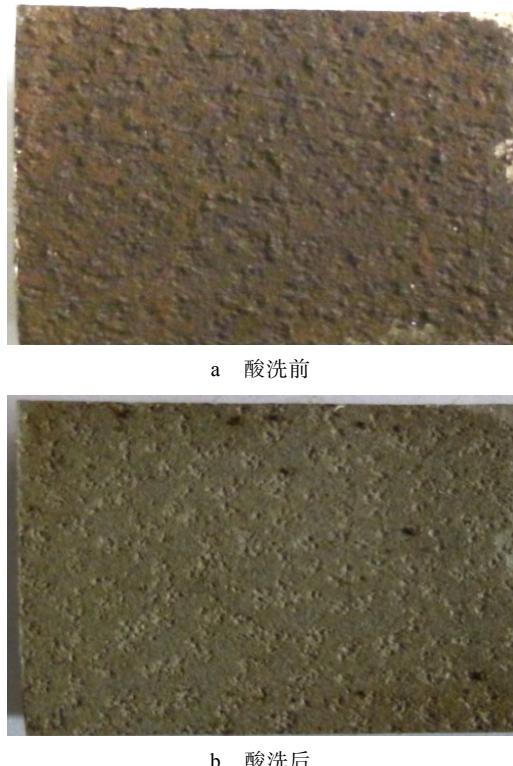
集腐蚀样品并结合ISO 8407—2009的推荐方法对管线内表层的腐蚀产物进行观察,结果如图1所示。对比试样表面酸洗前后的形貌可以发现,酸洗前后试样表面均分布有小鼓泡状腐蚀产物以及小麻点坑,表明该处管段发生了较为轻微的局部坑点腐蚀。

图 1 AB 段管道内表面 12 点钟方向 (顶端) 酸洗前后的腐蚀形貌

Fig.1 Corrosion morphology of AB section in 12 o'clock direction (top) on pipe surface before (a) and after (b) pickling

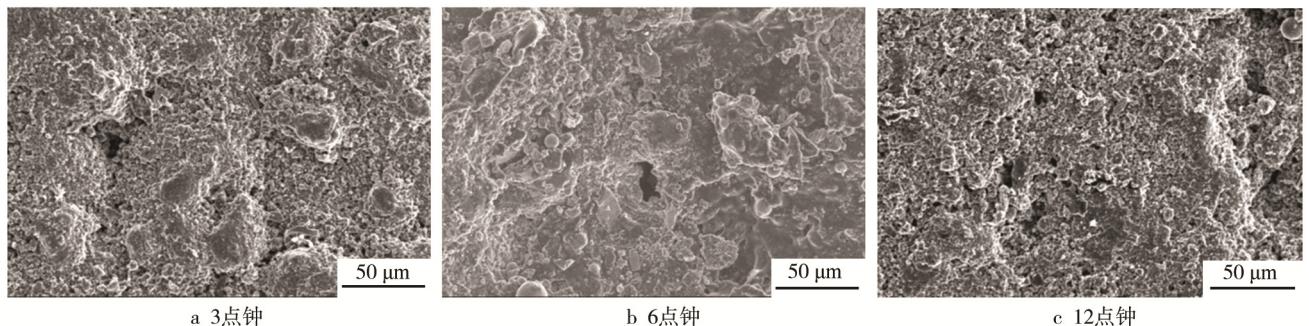
图 2 AB 段更换管段表面腐蚀产物的微观形貌

Fig.2 Microstructure of surface corrosion products in AB replacement section: a) in 3 o'clock, b) 6 o'clock, c) 12 o'clock direction

为了进一步观察表面腐蚀产物的形貌、组成以及点蚀坑形态,通常将 SEM 和 EDS 结合使用,检测形貌的同时进行元素的原子分数和质量分数分析。管道表面不同方位 (3、6、12 点钟方位) 腐蚀产物的形貌如图 2 所示。

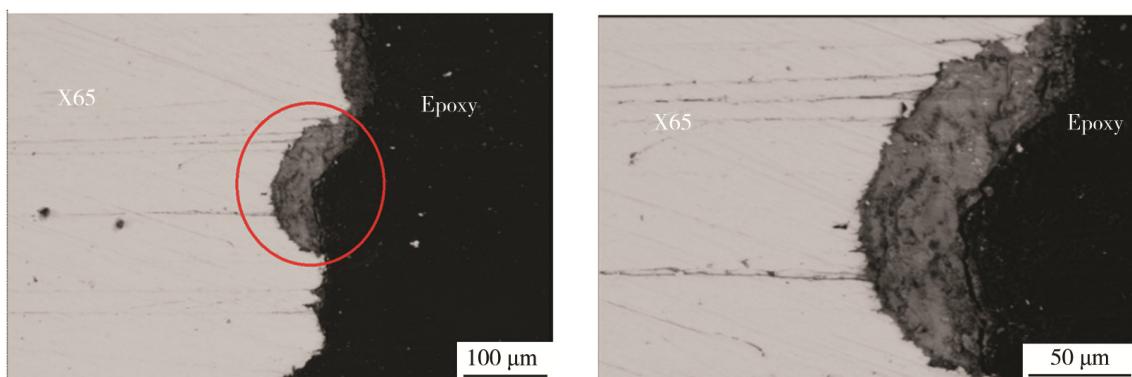
图 3 AB 段更换管段 3 点钟方向截面形貌分析图

Fig.3 Cross-sectional morphology analysis of in 3 o'clock direction in AB replacement section

图 3—图 5 为更换管段不同方位的截面形貌分析图,表 2—表 4 为对应方位的 EDS 分析结果。从分析结果可以看出,管段不同方位处的腐蚀产物均存在于孔隙中,其明显为局部腐蚀的发生和发展提供了有利条件。截面微观形貌显示,不同方位都发生了不均匀腐蚀行为,12 点钟方向腐蚀坑深度约为 0.18 mm,3 点钟和 6 点钟方向腐蚀坑深度均约为 0.1 mm,6 点钟方向的腐蚀产物厚度最大,3 点钟方向的腐蚀产物厚度最小,同时 12 点钟方向的腐蚀产物中夹杂有黑色腐蚀产物。根据 EDS 结果可以看出,该段管线 3、6 点钟方向的腐蚀产物主要含有 Fe、O、C,12 点钟方向的黑色腐蚀产物含有 S,并推测 S 以 Fe 的硫化物存在。

通过EDS分析结果确定管段12点钟方位(顶部)的腐蚀产物有FeCO₃、Fe₂O₃、SiO₂等,其中FeCO₃占主要组分,因此可以推断该处管段顶部发生了较为严重的CO₂腐蚀,对应腐蚀产物为黑褐色物质,同时Fe或Fe的腐蚀产物暴露于空气中被氧化,会产生少量的Fe₂O₃。腐蚀产物中SiO₂的存在可能是由于管线内残余的污泥本身所含。结合EDS分析结果发现,有S元素存在于管线顶部腐蚀产物中,推测可能有硫酸盐还原菌的存在。管线3点钟和6点钟方位的腐蚀产物主要以FeCO₃为主,并含有少量泥沙,即3点钟

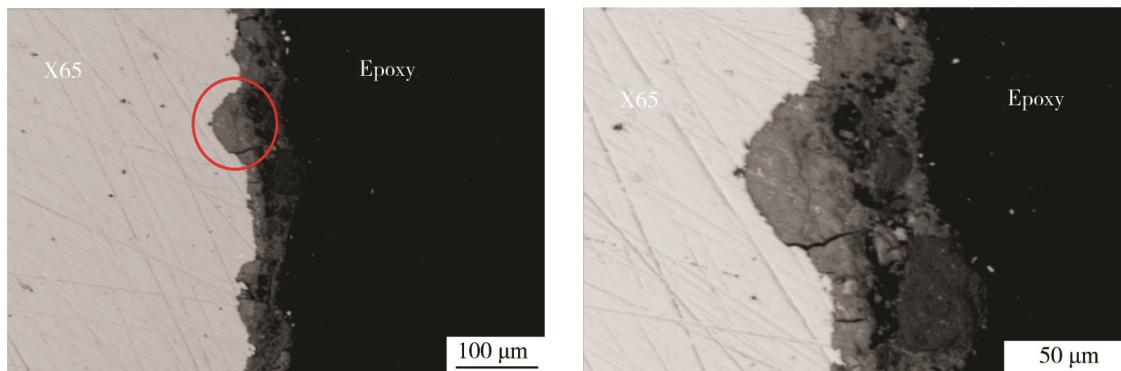
图4 AB段更换管段6点钟方向截面形貌分析图

Fig.4 Cross-sectional morphology analysis of AB replacement section in 6 o'clock direction

区域的腐蚀同样以 CO₂ 腐蚀为主, 同时 6 点钟方位有少量的 Fe₂O₃ 和泥沙, 没有发现微生物腐蚀的腐蚀产物。

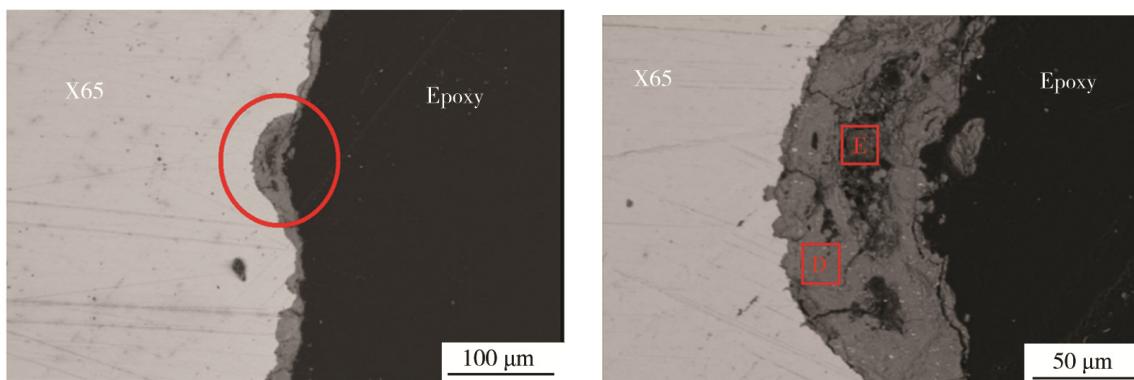
图5 AB段更换管段12点钟方向截面形貌分析图

Fig.5 Cross-sectional morphology analysis of AB replacement section in 12 o'clock direction
