热镀锌双相钢钢板表面橘皮缺陷研究

摘要: **目的** 研究一种热镀锌双相钢表面橘皮状缺陷的特征及形成机理。**方法** 采用数字显微镜、扫描电镜和辉光光谱仪对正常和缺陷位置的镀锌态、去锌层态、冷轧态和热轧态的形貌和表层成分分布开展对比分析研究。**结果** 橘皮状缺陷特征是由于锌晶粒异常长大至 350 μm , 为正常晶粒的 4 倍。镀锌态缺陷区较正常区 Mn 含量高 26%, 纵截面观察基板表层有约 2~4 μm 深的微裂纹, 界面处检测出 Al、O、Mn 峰, 存在 Mn 表面富集。去锌层态和冷轧态基板表层呈冷轧轧裂特征, 存在大量垂直于轧制方向的 10~30 μm 的横向微裂纹。卷取温度为 650 $^{\circ}\text{C}$ 时, 热轧态边、中位置氧化层厚度分别为 6.5、5.8 μm , 较 550 $^{\circ}\text{C}$ 时增加 25% 和 23%。GDS 检测表明, 对应缺陷区热轧态发生共析转变, 相构成以低氧含量的 Fe_3O_4 、 FeO 、 Fe 为主。实践证实, 卷取温度下调至 560 $^{\circ}\text{C}$ 以下时, 可有效消除该缺陷。**结论** 缺陷形成机理是, 热轧钢卷在 570 $^{\circ}\text{C}$ 以上温度卷取, 经缓慢冷却至室温时, 形成纯铁包覆 Fe_3O_4 的共析转变氧化铁皮, 卷取温度高也使氧化层增厚, 导致酸洗难度增大, 氧化铁皮无法有效清除。酸洗后残存的氧化层和 Mn 富集导致表层协同变形能力弱, 冷轧形成大量 10 μm 级横向微裂纹。微裂纹处的凹凸表面诱发 Fe-Zn 相爆发生长, 导致锌晶粒异常长大。厚带钢具有更多的内部热量, 出锌锅冷速慢, 也为镀后锌晶粒长大创造条件。

Investigation of Orange Peel-like Defects on Galvanized DP Steel Sheets

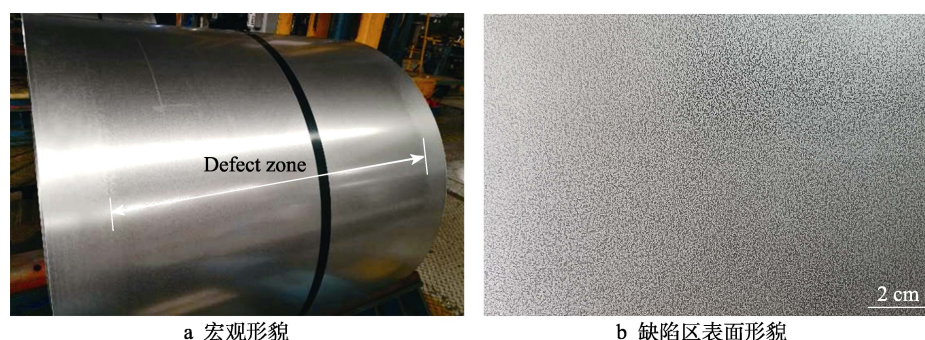
图 1 橘皮缺陷

镀锌 DP 钢橘皮缺陷宏观形貌及局部放大形貌如图 1 所示。肉眼观察板宽中间区域色泽亮, 表现出明

Fig.1 Orange peel-like defects: a) macro morphology; b) surface appearance in defective zone

显的边中色差,中间缺陷区锌层粗糙,呈橘皮状,严重时手感,缺陷随厚度规格、产品强度等级的增加而加重。缺陷通常发生于钢卷中部区域,头尾约 100~150 m 及距边部 15 cm 区域锌层正常。

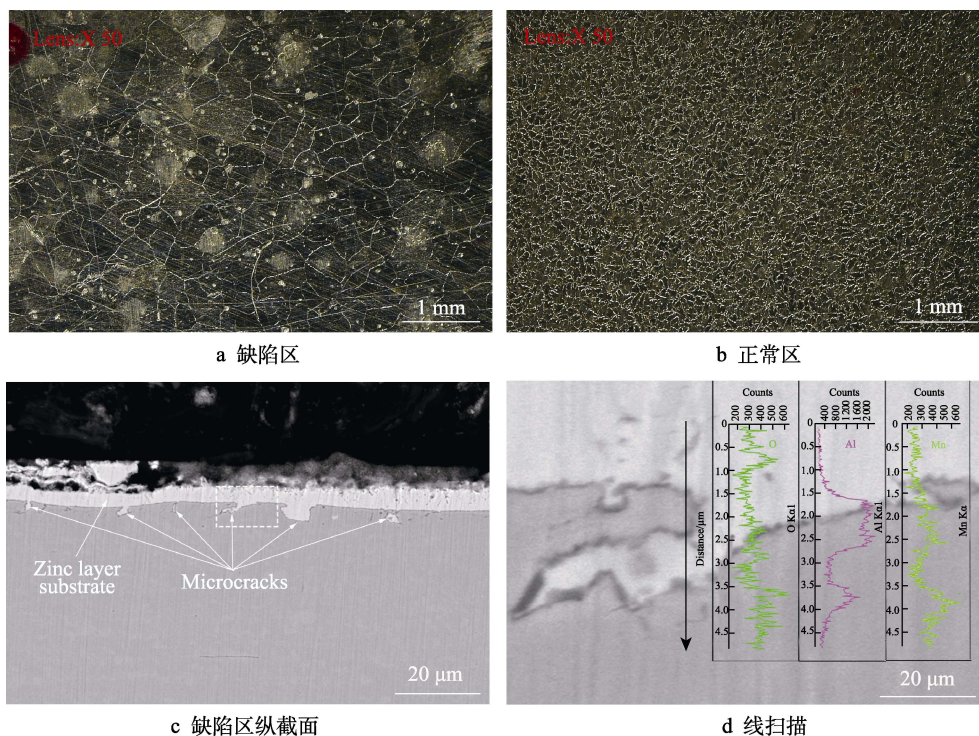
图 2 镀锌态表面及截面形貌

图 2a、b 为 DS 观察的中间缺陷区和边部正常区的未经光整处理的锌层表面微观形貌。缺陷区锌层晶粒尺寸约为 350 μm ,而正常区约为 90 μm ,缺陷区存在锌层晶粒异常长大。图 2c 为 SEM 观察的缺陷区纵截面形貌,基板表面可以发现大量的微裂纹,微裂纹深度约为 2~4 μm 。图 2d 为图 2c 虚线框区域形貌,线扫描检测结果表明,在基板表面存在 O、Mn、Al 峰。

Fig.2 Surface and cross section morphology at the galvanized state: a) defective zone; b) normal zone; c) longitudinal cross section of defective zone; d) line scanning

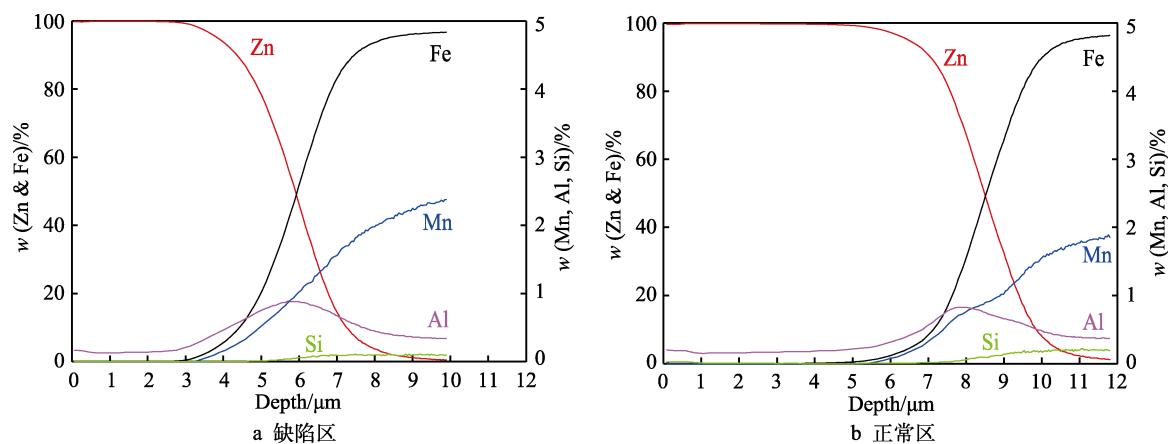
图 3 镀锌态表面 GDS 检测结果

图 3 为缺陷区和正常区的 GDS 检测结果。缺陷区和正常区 Al 的质量分数峰值分别为 0.89% 和 0.84%,表明在锌层与相界面处均有同等的 Fe-Al 相生成。Mn 的质量分数的最大值分别为 2.4% 和 1.9%,表明缺陷区 Mn 表面富集程度高于正常区域。

Fig.3 GDS results of galvanized state: a) defective zone; b) normal zone

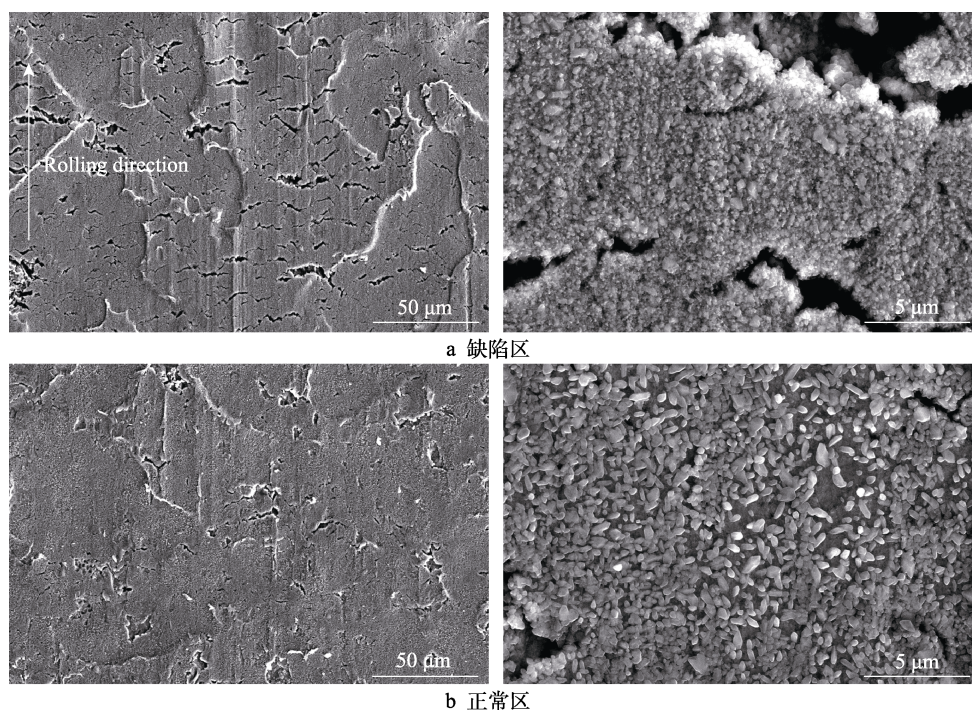
图 4 去锌层态基板表面和抑制层形貌

图 4a、b 为去除锌层状态下观察的缺陷区和正常区基板表面二次电子 SEM 形貌。图 4a 中缺陷区基板表面存在高密度的垂直于轧制方向的微裂纹,微裂纹长度为 10~30 μm 。局部放大观察基板表面 Fe-Al 相^[13]抑制层颗粒形貌无固定形态,形成不充分。图 4b 中正常区的 Fe-Al 相抑制层颗粒呈现较规则的短棒状,形成充分,可以确认锌层粘附性较好。

Fig.4 Substrate and inhibition layer morphology after removing the zinc layer:

a) defective zone; b) normal zone

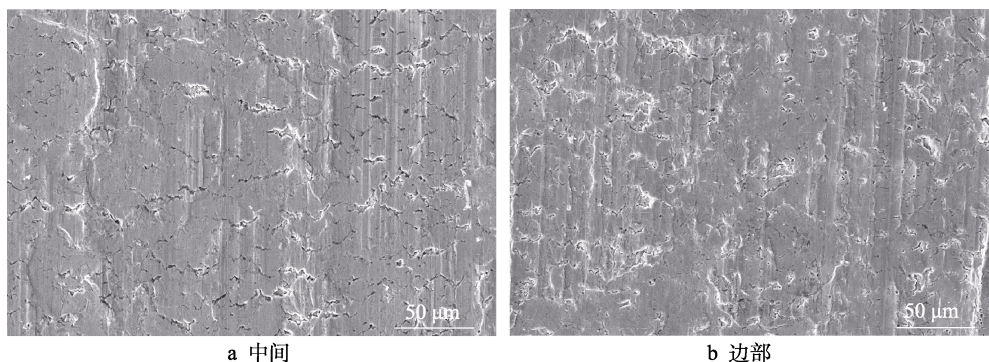
图 5 轧硬卷表面 SEM 形貌

为进一步证实微裂纹产生工序, 借助 SEM 确认轧硬卷表面形貌 (如图 5 所示)。为便于观察差异, 试样经 5% HCl 溶液 (添加少量乌洛托品缓蚀剂控制侵蚀速率) 侵蚀 2 min, 酒精溶液电磁振荡清洗去除表面油渍及异物。中间缺陷区表面与去锌层态时一致, 存在同等大小和密度的横向微裂纹; 边部正常区几乎观察不到横向微裂纹现象。这表明, 微裂纹在冷轧工序就已形成, 非热镀锌工序产生。

Fig.5 SEM morphology of full hard coil: a) center; b) side

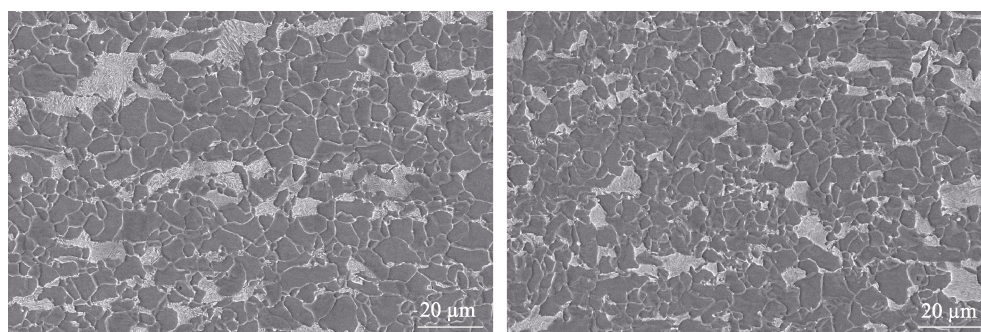
图 6 650 °C 卷取时热轧态 SEM 组织形貌

650 °C 时的热轧卷中部板宽边、中位置的 SEM 组织形貌如图 6 所示, 热轧基体组织为铁素体+珠光体组织。表面 GDS 对比检测的成分分布曲线如图 7 所示, 分别用实线和点划线表征板宽边、中位置的检测结果。可以发现, 中间位置的 Si、Mn、Cr 峰值均较边部位置略高, 峰值分别增加 15%、23% 和 28%, 存在表面富集现象。为便于比较, 以 5% O 含量作为热轧氧化层和基体的分界面, 中间和边部位置的氧化层厚度分别为 6.5 μm 和 5.8 μm, 中间位置氧化层更厚, 厚度约增加 12%。表层到基体的 O 含量均呈逐渐下降趋势, 中间位置的 O 含量梯度变化趋势更缓慢, 这表明 2 个位置的氧化铁皮层相构成存在差异。

Fig.6 Micro-structure of hot rolled state at CT of 650 °C: a) center; b) side

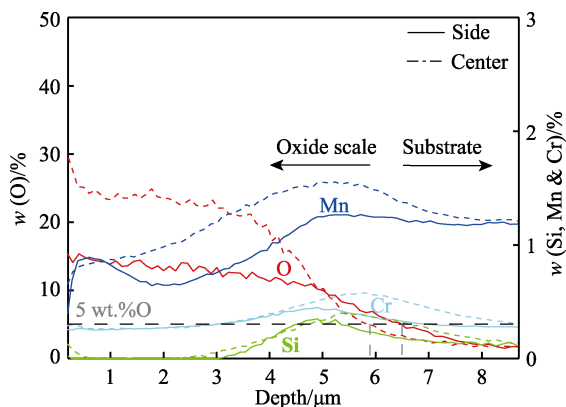
图 7 CT 为 650 °C 时热轧态 GDS 检测结果

Fig.7 GDS result of hot rolled state at CT of 650 °C

研究表明, 650 °C 卷取时, 热卷中部中间位置 Mn 元素表面富集明显, GDS 检测结果显示, Mn 峰较边部位置约增加 23%, 这与中间位置处于高温的时间更长有重要关系。氧化铁皮厚度为 6.5 μm, 较边部位置增厚 12%, 较 550 °C 卷取对应位置增厚 25%, O 含量明显低于边部位置, 氧化铁皮相构成差异明显。基于氧化层各相 (Fe_2O_3 、 Fe_3O_4 、 FeO 、 Fe) 的 O 含量可以推断, 边部位置以高 O 含量的 Fe_2O_3 、 Fe_3O_4 、 FeO 为主, 中间位置以低 O 含量的 Fe_3O_4 、 FeO 、 Fe 为主。更为重要的是, 热卷从 650 °C 缓慢冷却到室温时, FeO 在 570 °C 时开始共析转变为 Fe_3O_4 和纯铁^[17-19] (见图 11)。共析转变形成的纯铁包覆 Fe_3O_4 的氧化铁皮严重影响酸洗效果^[20-22], 而过厚的氧化铁皮也会增加酸洗难度, 进而导致酸洗效果不佳, 造成表面氧化物残存。

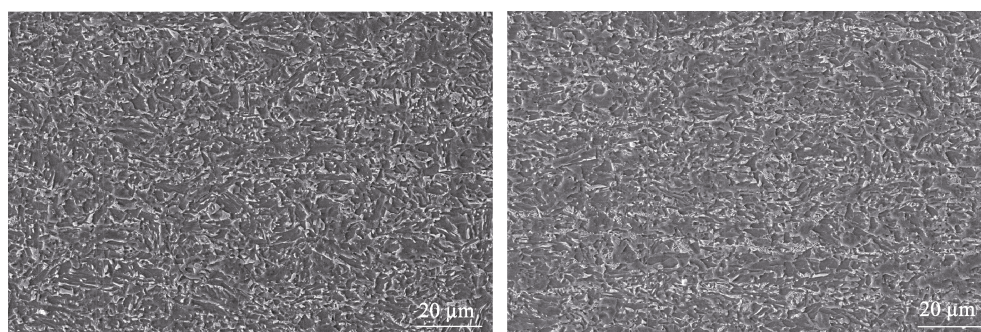
图 8 550 °C 卷取时热轧态组织形貌

Fig.8 Micro-structure of hot rolled sheet at CT of 550 °C: a) center; b) side

橘皮缺陷发生位置对应热轧钢卷芯部(非暴露部位),该部位特点是冷却速率慢,高温时间长。实践验证表明,热轧卷 CT 由原有的 650 °C 下调至 560 °C 及以下时,冷轧表面轧裂现象消失,可有效消除该表面缺陷。热轧 CT 为 550 °C 时的热轧卷中部板宽边部和中间位置的 SEM 组织形貌如图 8 所示,热轧基体组织均为铁素体+马氏体+珠光体+少量贝氏体组织。对应的表面 GDS 对比检测的成分分布曲线如图 9 所示。检测表明,中间位置的 Mn 元素表面富集现象弱化。表层到基体的 O 含量呈逐渐下降趋势,但边、中氧化铁皮层基本保持一致,与卷取为 650 °C 的边部位置变化规律一致。中、边部位置的氧化层厚度分

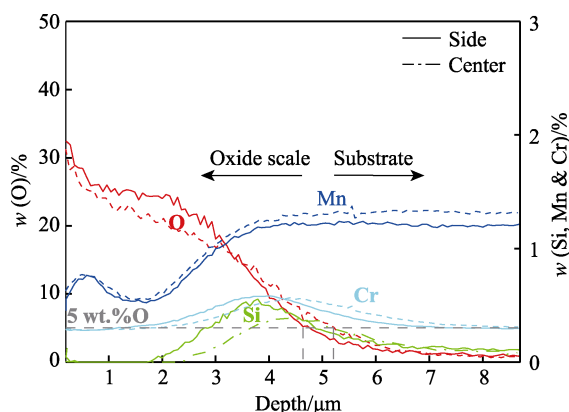
图 9 CT 为 550 °C 时热轧态 GDS 检测结果
Fig.9 GDS result of hot rolled surface at CT of 550 °C

别为 5.2 μm 和 4.7 μm, 较 650 °C 卷取时有较明显减薄, 减薄比例分别为 20% 和 19%。

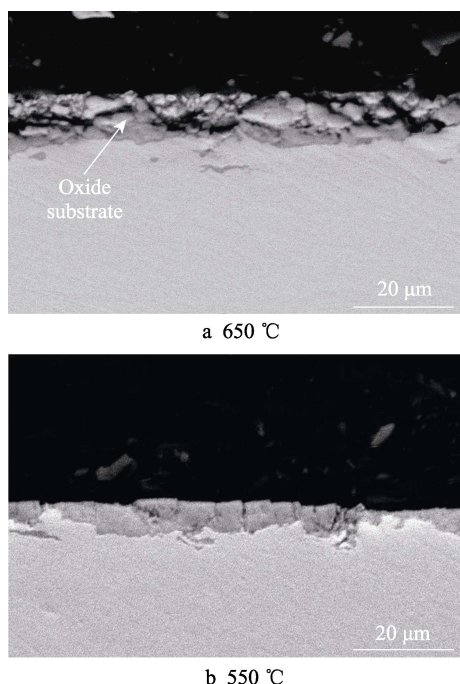
CT 为 650、550 °C 时对应缺陷位置热轧态截面 SEM 形貌如图 10 所示, 表面氧化层厚度分别约为 9.2 μm 和 7.0 μm。热轧态氧化层 SEM 检测结果进一步证实, 在高 CT 温度下, 热轧氧化层厚度增加, 增加比例约为 31%, 低 CT 有助于降低热轧态表面的氧化层厚度。

图 10 CT 为 650 °C 和 550 °C 时热轧截面 SEM 形貌
Fig.10 SEM morphology for hot rolled cross section at CT of 650 °C and 550 °C
