油气管道 SRB 腐蚀研究新进展

摘要: 由硫酸盐还原菌(SRB)引发的腐蚀是造成管道材料破坏和失效的重要原因, 研究微生物腐蚀机制和防控措施具有重要的科学意义和经济价值。首先通过介绍国内外油气管道微生物腐蚀的失效案例, 说明 SRB 对油气管道破坏的严重性。接着介绍了管道表面微生物膜的微观形成过程和结构特点, 梳理了微生物膜作用下管材发生局部腐蚀的机理, 主要对当前较为流行的微生物电化学腐蚀(EMIC)理论和管道微生物腐蚀预测模型做了深入探讨。综合考虑管道运行实际工况, 结合模拟试验结果, 进一步阐述了管线钢即使处于正常阴极保护条件下, 由于受 SRB 生命代谢活动的影响, 管道表面 Fe 中的电子通过细菌的新陈代谢作用直接获取, 从而导致管材依然发生局部腐蚀甚至更为严重。而焊缝及其附近热影响区是管道发生腐蚀穿孔的薄弱区。最后全面总结了油气管道工业中抗 SRB 腐蚀防护前沿的理念和方法, 分析了当前各种防护技术在实际应用中的不足, 对微生物腐蚀如何更有效地防治提供了富有价值的参考, 为管道工程 SRB 腐蚀防护技术的未来发展指明了方向。

Research Progress on Oil & Gas Pipeline Corrosion Induced by SRB

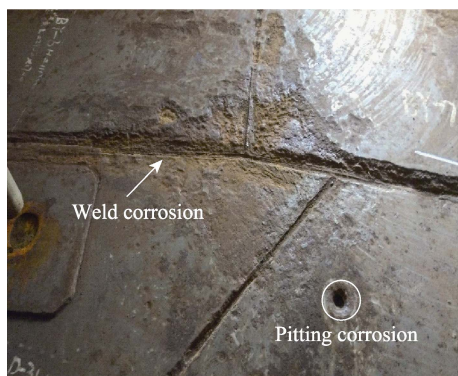
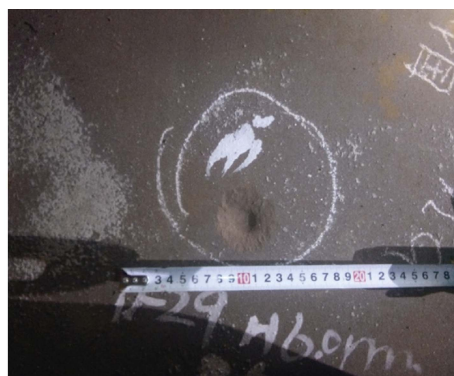
图 1 SRB 导致 Q235 罐板的局部腐蚀

Fig.1 Tank plate Q235 localized corrosion induced by SRB
