热镀锌双相钢钢板表面橘皮缺陷研究

摘要: **目的** 研究一种热镀锌双相钢表面橘皮状缺陷的特征及形成机理。**方法** 采用数字显微镜、扫描电镜和辉光光谱仪对正常和缺陷位置的镀锌态、去锌层态、冷轧态和热轧态的形貌和表层成分分布开展对比分析研究。**结果** 橘皮状缺陷特征是由于锌晶粒异常长大至 350 μm , 为正常晶粒的 4 倍。镀锌态缺陷区较正常区 Mn 含量高 26%, 纵截面观察基板表层有约 2~4 μm 深的微裂纹, 界面处检测出 Al、O、Mn 峰, 存在 Mn 表面富集。去锌层态和冷轧态基板表层呈冷轧轧裂特征, 存在大量垂直于轧制方向的 10~30 μm 的横向微裂纹。卷取温度为 650 $^{\circ}\text{C}$ 时, 热轧态边、中位置氧化层厚度分别为 6.5、5.8 μm , 较 550 $^{\circ}\text{C}$ 时增加 25% 和 23%。GDS 检测表明, 对应缺陷区热轧态发生共析转变, 相构成以低氧含量的 Fe_3O_4 、 FeO 、 Fe 为主。实践证实, 卷取温度下调至 560 $^{\circ}\text{C}$ 以下时, 可有效消除该缺陷。**结论** 缺陷形成机理是, 热轧钢卷在 570 $^{\circ}\text{C}$ 以上温度卷取, 经缓慢冷却至室温时, 形成纯铁包覆 Fe_3O_4 的共析转变氧化铁皮, 卷取温度高也使氧化层增厚, 导致酸洗难度增大, 氧化铁皮无法有效清除。酸洗后残存的氧化层和 Mn 富集导致表层协同变形能力弱, 冷轧形成大量 10 μm 级横向微裂纹。微裂纹处的凹凸表面诱发 Fe-Zn 相爆发生长, 导致锌晶粒异常长大。厚带钢具有更多的内部热量, 出锌锅冷速慢, 也为镀后锌晶粒长大创造条件。

Investigation of Orange Peel-like Defects on Galvanized DP Steel Sheets

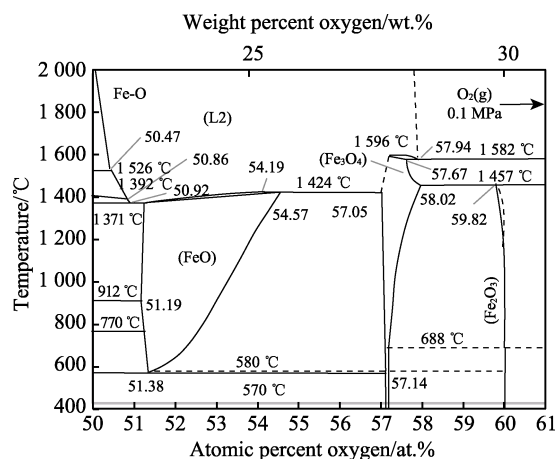
图 11 铁氧相图
Fig.11 Fe-O phase diagram

研究表明, 650 °C 卷取时, 热卷中部中间位置 Mn 元素表面富集明显, GDS 检测结果显示, Mn 峰较边部位置约增加 23%, 这与中间位置处于高温的时间更长有重要关系。氧化铁皮厚度为 6.5 μm, 较边部位置增厚 12%, 较 550 °C 卷取对应位置增厚 25%, O 含量明显低于边部位置, 氧化铁皮相构成差异明显。基于氧化层各相 (Fe_2O_3 、 Fe_3O_4 、 FeO 、 Fe) 的 O 含量可以推断, 边部位置以高 O 含量的 Fe_2O_3 、 Fe_3O_4 、 FeO 为主, 中间位置以低 O 含量的 Fe_3O_4 、 FeO 、 Fe 为主。更为重要的是, 热卷从 650 °C 缓慢冷却到室温时, FeO 在 570 °C 时开始共析转变为 Fe_3O_4 和纯铁^[17-19] (见图 11)。共析转变形成的纯铁包覆 Fe_3O_4 的氧化铁皮严重影响酸洗效果^[20-22], 而过厚的氧化铁皮也会增加酸洗难度, 进而导致酸洗效果不佳, 造成表面氧化物残存。
