# 饮用水水质对缺陷涂层腐蚀行为的影响

**摘要:** **目的** 研究带缺陷环氧富锌涂层在不同水质的饮用水模拟溶液中的腐蚀机理, 为饮用水输水管内壁涂层的选用提供建议。 **方法** 采用电化学阻抗谱(EIS)研究涂层浸泡过程中的电化学行为, 分别采用扫描电子显微镜(SEM)、EDS能谱仪和拉曼光谱对腐蚀产物的形貌和成分进行分析。 **结果** 在含 $\text{Ca}^{2+}$ 较多的溶液中, 缺陷处形成了致密的水垢, 并在水垢附近形成了双层锈结构; 在含 $\text{Ca}^{2+}$ 较少的溶液中, 垢的生长受到限制, 缺陷处布满黄锈, 并且起泡现象严重。 **结论** 涂层在硬度较小的溶液中具有更好的抗渗性; 而在硬度较大的溶液中更容易形成粗大而紧密堆积的碳酸钙柱状晶, 覆盖在缺陷处形成水垢, 阻碍涂层的阴极剥离和阴极起泡过程。对于输送软水的饮用水管道, 内壁涂层的防划伤是关键; 对于输送硬水的饮用水管道, 内壁涂层的抗渗能力是关键。

## Effects of Drinking Water Hardness on Corrosion Mechanism of Defected Coating

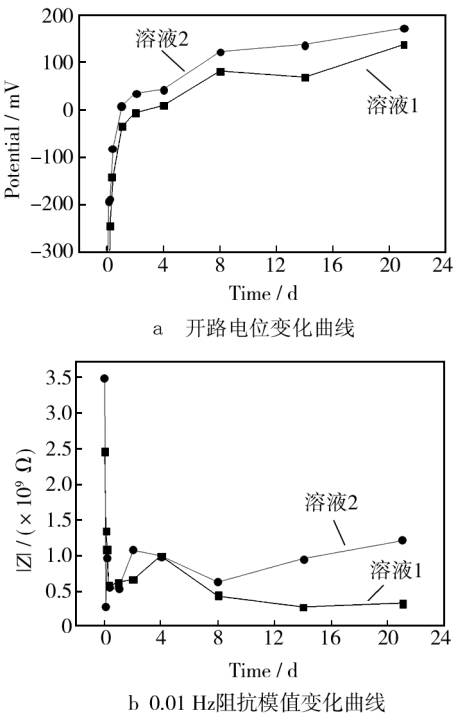
图 1 完好涂层试样在两种溶液中的 EIS 测试结果  
Fig. 1 Open circuit potential (a) and impedance module at frequency of 0.01 Hz versus (b) immersing time in solution 1 and 2 for intact coating sample

将完好涂层分别浸泡在两种模拟溶液中,在测试的 21 天内,其开路电位均正移,如图 1a 所示,但在溶液 2 中电位更高,即发生腐蚀的趋势更小。图 1b 的低频阻抗模值变化曲线表明,随着浸泡时间的延长,完好涂层在溶液 2 中的阻抗模值下降后,又小幅回

升,浸泡 21 天的阻抗模值比在溶液 1 中大 1 个数量级。由此可见,完好涂层在溶液 2 中具有更好的抗渗性。

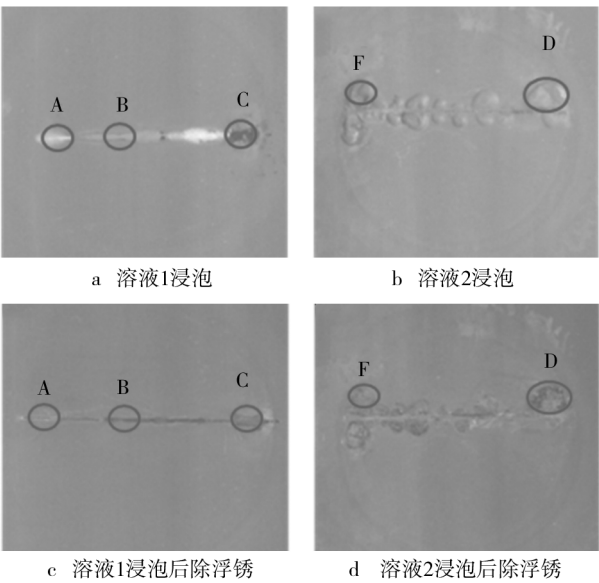
图 2 缺陷涂层试样浸泡后的表面宏观形貌  
Fig. 2 Surface morphologies of the defected coating after 21-day immersions : a) in solution 1, b) in solution 2, c) rust removal for solution 1, d) rust removal for solution 2

缺陷涂层试样分别在两种模拟溶液中浸泡 21 天后的表面宏观形貌如图 2 所示。图 2a 显示,涂层在溶液 1 中浸泡后未出现起泡现象,腐蚀产物仅在缺陷处堆积,并未向缺陷两侧的涂层下扩展。图 2b 显示,浸泡在溶液 2 中的涂层起泡现象非常严重,将 F 处拱起的涂层挑破后,可以看到泡下堆积着大量的锈蚀产物,如图 2d 所示。另外,从腐蚀产物的颜色分析,在两种溶液中的情况也有很大不同。在溶液 2 中,腐蚀产物为单一的黄锈,用细针轻轻刮去表层黄锈(D 处),观察到下层锈蚀产物仍以黄锈为主,只夹杂着很少量的白色物质,并未观察到有黑色锈蚀产物;在溶液 1 中,产物有白、黄、黑三种颜色,刮去上层物质后,发现 B 处黄锈下层为黑锈,C 处黑锈下基体表面覆盖有少量黄锈,而 A 处白色物质下为光亮的金属基板,无任何锈蚀迹象。

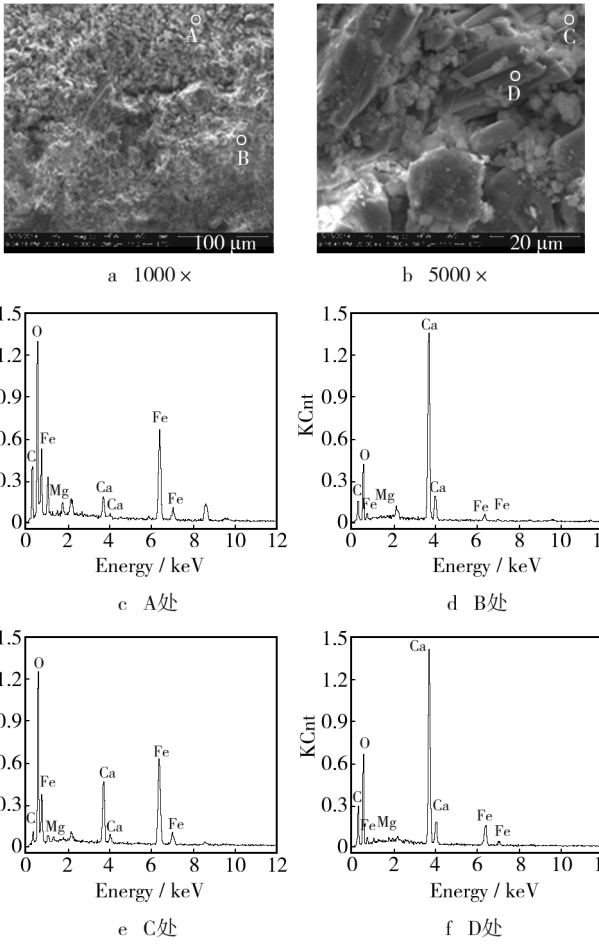
图 3 缺陷涂层试样在溶液 1 中浸泡后的 SEM 形貌及 EDS 能谱  
Fig. 3 SEM micrograph and EDS energy spectrum of defected coating after 17 days immersion in solution 1

图 3 为试样在溶液 1 中浸泡 17 天后缺陷处腐蚀

产物的SEM形貌及其EDS能谱图。从图3b可以看出,溶液1中涂层破损处的腐蚀产物形貌主要有两大类:一类呈较小的球状颗粒,从能谱(图3e)分析来看,球状腐蚀产物中含有大量的Fe和O元素,而Ca和Mg元素的含量较少,可推测其主要为Fe的腐蚀产物;另一类腐蚀产物为较粗的柱状晶,且晶柱生长较为充分,能谱图(图3f)显示,柱状晶中以Ca元素为主,几乎不含Fe元素,可见其主要为溶液中的 $\text{Ca}^{2+}$ 结晶析出的产物。另外,从图3a的较低倍照片中可以看出,腐蚀产物堆积较为紧密,出现了结块现象,能谱图显示板块处含有大量的Ca元素(见图3d)。由此可以推测,在腐蚀过程中,溶液中的 $\text{Ca}^{2+}$ 结晶析出形成水垢,堵塞在疏松的锈蚀孔隙中,结成致密的板块,阻挡了溶液的渗透。

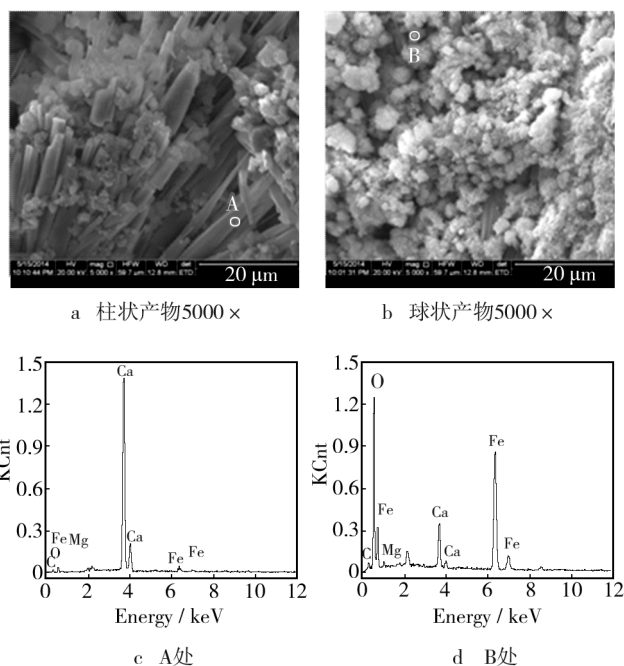
图4 涂层试样在溶液2中浸泡后的SEM形貌及EDS能谱  
Fig. 4 SEM micrograph and EDS energy spectrum of defected coating after 17 days immersion in solution 2

图4为试样在溶液2中浸泡17天后缺陷处腐蚀产物的SEM形貌及其EDS能谱图。图4中仍然可以观察到球状和柱状晶两种形态的腐蚀产物,其中球状产物含Fe元素较多,而柱状产物含有大量的Ca元素,这与在溶液1中的情况相似。不同的是,图4a显示在溶液2中的腐蚀产物堆积较为疏松,含Ca柱状晶细而短,并且间距较大。含Ca柱状晶生长受限导致缺陷处在溶液2中没有形成致密的水垢,溶液中的离子较易从缺陷处向两边涂层下扩散,这与之前的宏观形貌分析结果吻合。

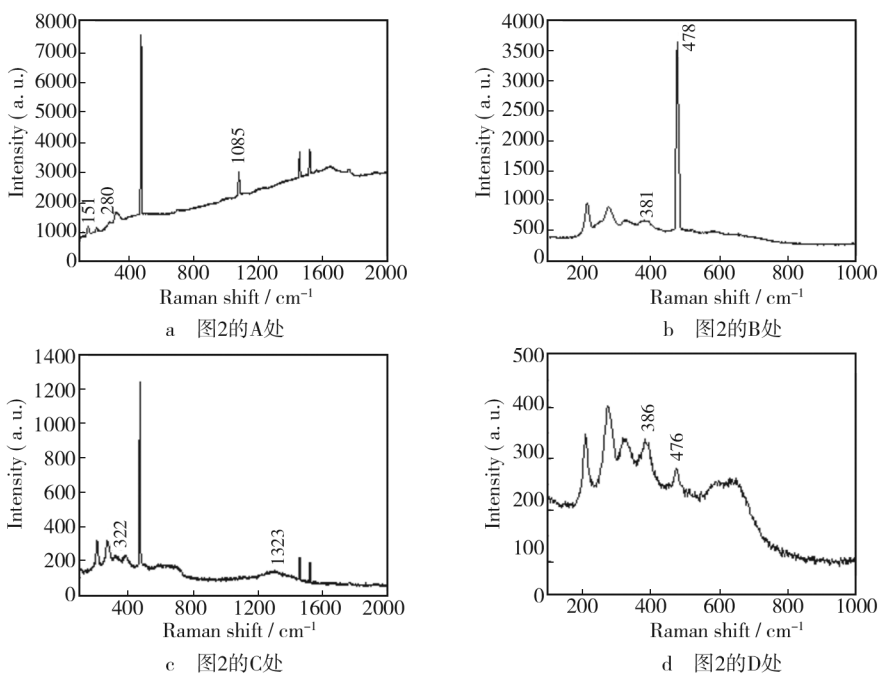
图 5 图 2 中各处不同腐蚀产物的拉曼光谱测试结果  
Fig. 5 Raman spectra of different corrosion products shown in Fig. 2

结合2.2小节中的腐蚀产物形貌分析,可以推测白色物质为钙的化合物,黄锈和黑锈均为铁的腐蚀产物。根据Reddy等人的报道<sup>[11]</sup>,缺陷涂层在腐蚀介质中会形成双层锈结构,外层为疏松的黄色铁锈 $\text{FeOOH}$ ,内层为致密的黑色铁锈 $\text{Fe}_3\text{O}_4$ 。因此可以推断,黄锈的主要成分为 $\text{FeOOH}$ ,黑锈可能为 $\text{Fe}_3\text{O}_4$ 。为了进一步确定腐蚀产物的具体成分,对图2中A、B、C、D四处进行了拉曼光谱分析,结果见图5。根据文献<sup>[12]</sup>,方解石( $\text{CaCO}_3$ )在常温下的拉曼光谱如图6所示。本实验测得白色腐蚀产物的拉曼光谱含有 $151, 280, 1085 \text{ cm}^{-1}$ 特征峰,见图5a,与 $\text{CaCO}_3$ 的拉曼峰 $155, 282, 1087 \text{ cm}^{-1}$ 相一致,因此判断白色产物为 $\text{CaCO}_3$ 。杨晓梅等<sup>[13]</sup>列出了 $\text{Fe}_3\text{O}_4$ 的拉曼特征峰位置,即 $298, 319, 420, 560, 680, 1322 \text{ cm}^{-1}$ ,图5c中黑锈的拉曼峰 $322, 1323 \text{ cm}^{-1}$ 与之吻合,可见黑色铁锈的成分为 $\text{Fe}_3\text{O}_4$ 。拉曼光谱中的 $383, 476 \text{ cm}^{-1}$ 两个峰代表晶体结构中 $\text{Fe—O—Fe}$ 和 $\text{—OH}$ 基团的存在<sup>[14]</sup>。Clark等<sup>[15]</sup>给出了黄色铁氢氧化物 $\text{FeO}(\text{OH})_x \cdot \text{H}_2\text{O}$ 的拉曼峰,即 $244, 299, 384, 412, 476, 543 \text{ cm}^{-1}$ ,图5b中的 $381, 478 \text{ cm}^{-1}$ 拉曼峰和图5d中的 $386, 476 \text{ cm}^{-1}$ 拉曼峰均能与之对应,说明在两种模拟溶液中浸泡得到的黄色铁锈均为 $\text{FeOOH}$ 。

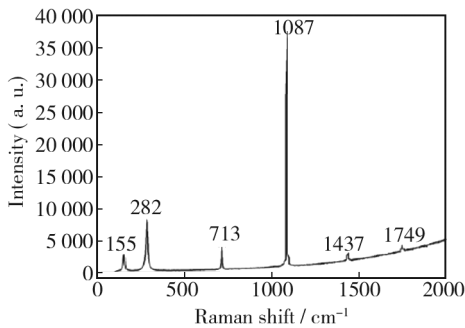
图 6 方解石在常温常压下的拉曼光谱<sup>[12]</sup>  
Fig. 6 Raman spectra of calcite at ambient temperature and pressure<sup>[12]</sup>
