# 脱脂对镀锌汽车板涂装性能影响

**摘要:** **目的** 研究脱脂影响镀锌钢板磷化反应的机理及电泳漆膜性能。**方法** 使用扫描电镜、电化学工作站、X 射线光电子能谱分析仪、成形试验机和循环式腐蚀试验机等设备研究了磷化膜形貌、表面元素、电化学性能以及电泳漆膜性能。**结果** 脱脂不良时磷化膜在镀锌钢板表面生长异常, 导致磷化膜呈现为明暗相间的花斑状; 表面元素和材料在磷化液中的电化学性能说明磷化膜生长异常的原因是残存油膜阻碍磷化反应进行, 同时异常磷化膜相对于正常磷化膜在 3.5% NaCl 溶液中开路电位负、阻抗小、自腐蚀电流大, 说明异常磷化膜耐蚀性能差, 易腐蚀; 电泳漆膜性能表明, 脱脂不良对漆膜的划格附着力影响小, 评级为 0 级, 但对电泳漆膜的杯突性能影响明显, 杯突高度为 6 mm 时, 漆膜发生破裂; 电泳耐蚀性能下降明显, 电泳漆膜扩蚀宽度从 2.4 mm 增加到 3.9 mm。**结论** 脱脂不良会导致镀锌板表面磷化膜质量异常, 进而影响电泳耐蚀性能, 在实际生产过程中, 需要对脱脂工序有效管控, 结合车身材料用油种类及油量及时调控参数, 避免脱脂不良问题出现。

## Effect of Degreasing on Coating Performance of Galvanized Automobile Sheet

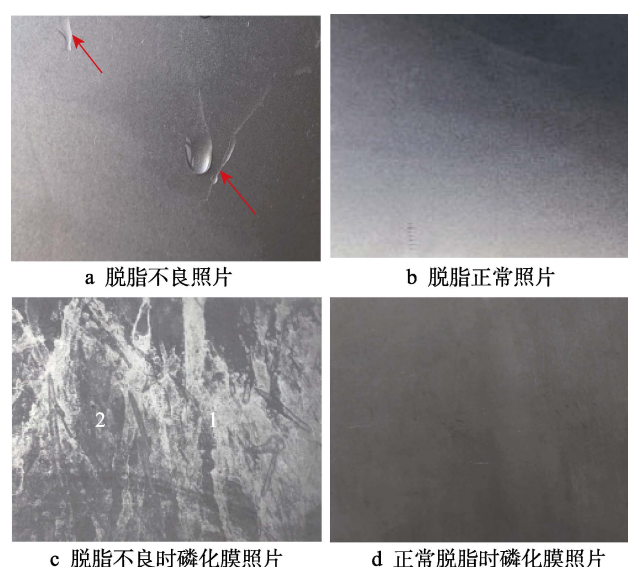
图 1 材料脱脂和磷化膜宏观照片

CR4+Z 在脱脂不良和正常脱脂条件下的磷化膜宏观形貌如图 1 所示, 磷化膜的微观形貌如图 2 所示。材料脱脂不良时, 材料表面水膜不连续, 存在滴状水流, 如图 1a 红色箭头指示处; 材料脱脂正常时, 表面水膜连续不破裂, 如图 1b 所示。材料脱脂不良和正常脱脂经过磷化处理后, 呈现为不同的宏观形貌, 脱脂不良时, 材料的磷化膜表现为花斑状, 明暗相间, 如图 1c 所示; 脱脂正常时, 材料的磷化膜均匀、致密、连续, 呈灰色, 表面无锈蚀、花斑, 无大的磷化渣附着, 也无严重挂灰, 外观质量良好, 如图 1d 所示。

Fig. 1 Macro photos of material degreasing and phosphating film: a) photos of poor degreasing; b) photos of normal degreasing; c) photos of phosphating film when degreasing is poor; d) macro photos of phosphating film when degreasing is normal

磷化膜的微观形貌如图 2 所示。图 2a、2b 分别为图 1c 中 1 和 2 位置的磷化膜电镜图, 1 位置处磷化膜为扁平化生长, 平铺在钢板表面, 2 位置处磷化膜为团簇状, 少量磷化膜垂直于钢板方向生长, 大部分存在倒伏现象, 近似于 1 位置处磷化膜为扁平化生长, 图 2c 为图 1d 正常磷化膜的微观形貌, 整体为团簇状, 垂直于钢板方向生长, 倒伏少。从微观形貌分析可知, 磷化膜在钢板表面存在状态的差异是导致了磷化膜在宏观外观上存在区别的原因。磷化膜存在扁平生长和较多倒伏的状态下, 对光线的镜面反射率较高, 磷化膜外观表现比较亮, 而正常磷化膜对光线漫反射比例较高, 外观表现颜色较暗。

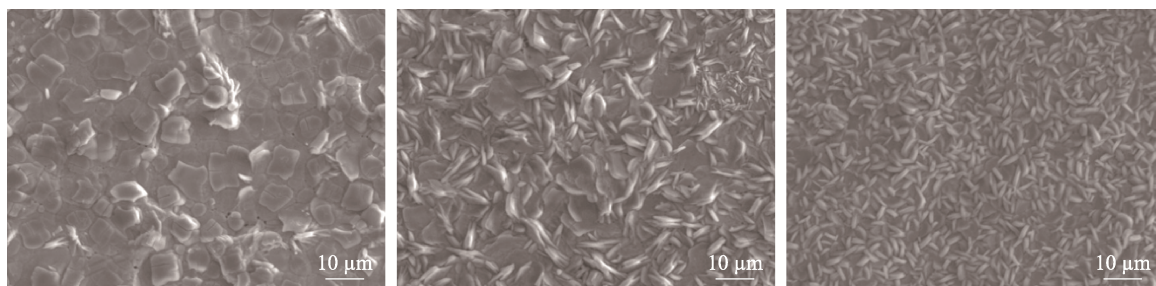
图 2 不同位置磷化膜微观形貌

a 图1c中1位置磷化膜形貌

b 图1c中2位置磷化膜形貌

b 图1d 磷化膜形貌

Fig.2 Microstructure of phosphating film at different positions: a) microstructure of phosphating film at position 1 in figure 1c; b) microstructure of phosphating film at position 2 in figure 1c; c) microstructure of phosphating film in figure 1d

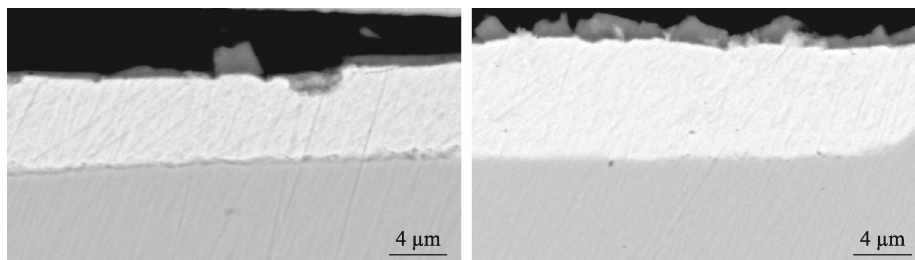
图 3 不同脱脂条件下的磷化膜截面图

由图 3 材料磷化处理后的截面图像可见, 镀层的厚度为  $6 \sim 8 \mu\text{m}$ , 磷化膜存在扁平生长和较多倒伏的状态下, 磷化膜的厚度为  $0.5 \sim 1 \mu\text{m}$ , 磷化膜正常时,

厚度在 1~2  $\mu\text{m}$ , 磷化膜异常处厚度明显低于正常处。

Fig.3 Cross-section of phosphating film under different degreasing conditions: a) poor degreasing; b) normal degreasing

重为  $1.67 \text{ g/m}^2$ , 磷化膜正常时膜重为  $2.79 \text{ g/m}^2$ , 说明磷化膜异常时膜厚偏薄, 与图 3 的分析结果是一致的。材料表面主要以 Zn 和 O 元素为主, 含有少量 P 和 Al 元素。因为镀锌锌锅中含有质量分数小于 0.5% 的 Al, 所以 Al 元素来自于 Zn 镀层。脱脂好坏对磷化膜去除后材料表面元素种类影响较小。从 P 2p 结合能为  $134.2 \text{ eV}$ <sup>[18]</sup>, 可以判断 P 以磷酸盐的形式存在于材料表面, Al 2p 结合能为  $74.6 \text{ eV}$ <sup>[19]</sup>, 说明 Al 元素以氧化物形式存在, 而 Zn 2p<sub>1/2</sub> 及 2p<sub>3/2</sub> 的结合能分别为  $1021.9 \text{ eV}$  和  $1045.0 \text{ eV}$ , 说明 Zn 在材料表面存在 ZnO 及  $\text{ZnAl}_2\text{O}_4$ <sup>[20]</sup>。由于磷酸盐和金属氧化物中都存在氧元素, 结合锌和铝的氧化物及磷酸盐中 O 元素的结合能分别为  $530.3 \text{ eV}$ <sup>[21-22]</sup> 和  $531.7 \text{ eV}$ <sup>[18]</sup>, 分峰拟合后计算得到磷化膜异常处的金属氧化物和磷酸盐含量分别为 39% 和 61%, 磷化膜正常处的金属氧化物和磷酸盐含量分别为 21% 和 79%。磷化膜异常处金属氧化物含量明显高于正常处, 这说明脱脂不良时, 材料表面存在的油膜阻碍了磷化液与镀锌层表面的反应, 镀锌层表面的氧化物溶解减缓, 从而阻碍镀锌层的溶解, 导致  $\text{Zn}^{2+}$  溶解量较少, 抑制了磷化反应, 从而导致磷化膜生长异常。

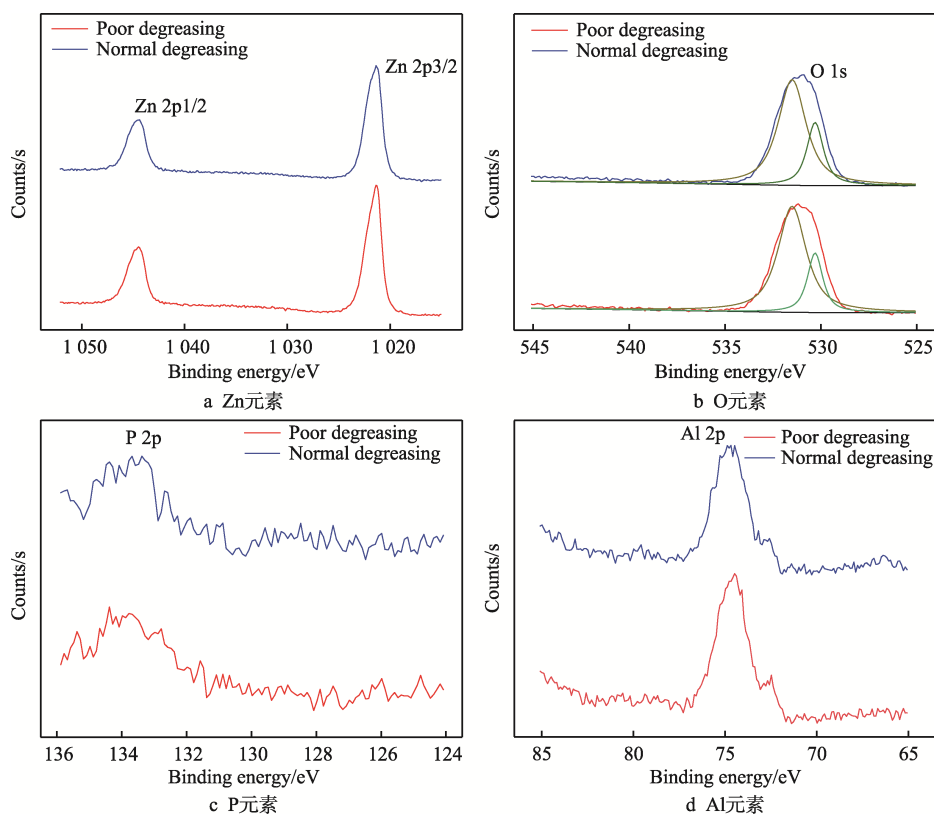
图 4 不同脱脂条件下磷化膜溶解后钢板表面元素 XPS 结果

unit area-Gravimetric methods》标准将磷化膜溶解去除, 再进行元素的 X 射线光电谱分析, 结果如图 4 所示。磷化膜去除后, 计算得到磷化膜异常时膜

Fig.4 XPS results of steel sheet surface elements after phosphating film dissolution under different degreasing conditions: a) Zn element; b) O element; c) P element; d) Al element

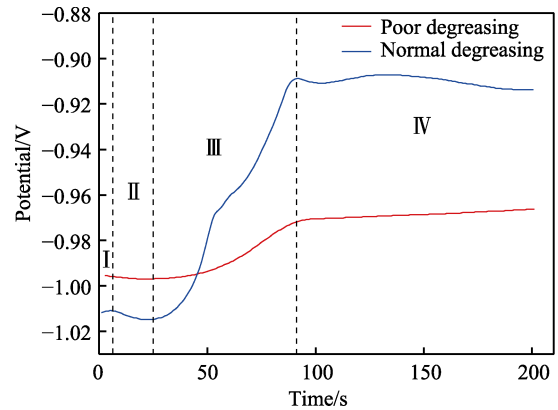
图 5 镀锌板在磷化液中的开路电位  
Fig.5 Open circuit potential of galvanized sheet in phosphating solution

通过电位-时间的测定, 可以监测磷化膜的生长过程。图 5 展示了在脱脂不良和脱脂正常的条件下, 镀锌板经过表调之后在磷化液中的电位变化。明显发现, 在脱脂正常的条件下, 镀锌板在磷化液中的开路电位分为 4 个阶段<sup>[24-25]</sup>, 第 I 阶段 (0~5 s) 电位从初始值位置轻微升高, 对应镀锌板表面 Zn 层初期溶解活化过程; 由于溶解速度加快, 在局部阳极区域产生的  $\text{Zn}(\text{H}_2\text{PO}_4)_2$  浓度迅速增加而达到饱和, 并在局部阴极溶解以不可逆的无定形形态沉积在 Zn 层表面, 导致电位下降, 即第 II 阶段磷化膜早期快速萌发和生长过程 (5~25 s); 随着磷化膜在钢板表面逐渐形成, 磷化膜覆盖率逐渐提高, Zn 层裸露面积逐渐减少, 锌的溶解速度减慢, 阳极过程逐渐减慢, 导致电位逐渐上升, 90 s 时为反应平衡节点, 即第 III 阶段 (25~90 s); 在磷化反应的最后第 IV 阶段 (>90 s), Zn 层表面全部覆盖磷化膜, 同时抑制了阳极过程 (Zn 层溶解) 和阴极过程 (析氢反应), 处于反应平衡阶段, 最终电位保持稳定。依据上述磷化膜的生长过程, 将磷化时间定为 120 s 是相对合理的, 一方面可以避免在 90 s 反应平衡节点附近磷化膜质量的波动, 确保磷化膜质量, 另一方面可以避免磷化时间过长导致涂装生产效率下降。

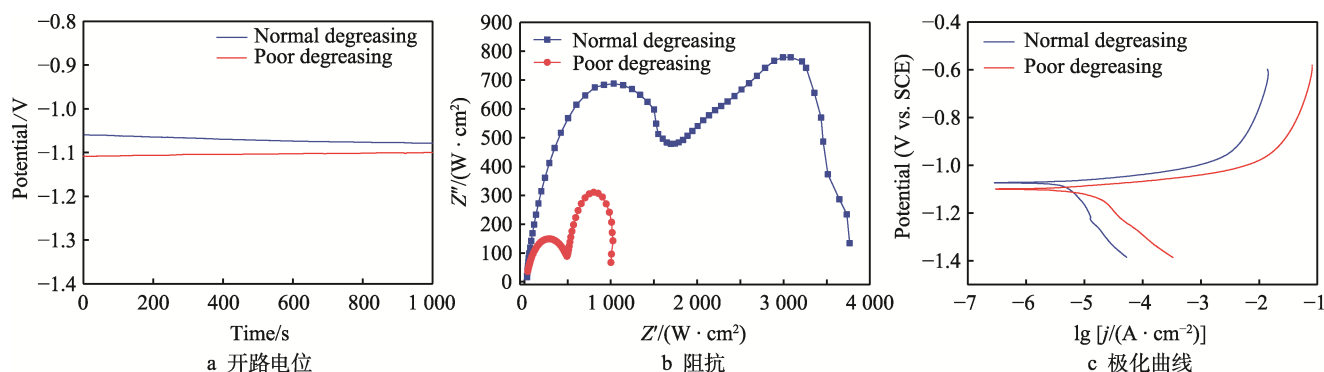
图6 不同脱脂条件下的磷化膜在3.5%NaCl溶液中的开路电位、阻抗和极化曲线

为了进一步分析磷化膜的耐蚀性能, 在 3.5% 的 NaCl 溶液中分析了不同脱脂条件下磷化膜的开路电位, 阻抗和极化性能, 结果如图 6 及表 1 所示。脱脂不良和脱脂正常时磷化膜阻抗图均为双阻抗弧, 脱脂正常时磷化膜阻抗为  $3.72 \times 10^3 \Omega \cdot \text{cm}^2$ , 脱脂异常时磷化膜阻抗为  $1.18 \times 10^3 \Omega \cdot \text{cm}^2$ , 正常磷化膜阻抗大于异常磷化膜阻抗; 从开路电位和极化曲线分析可知, 脱脂正常时磷化膜开路电位为  $-1.06 \text{ V}$ , 自腐蚀电流密度为  $7.94 \times 10^{-6} \text{ A} \cdot \text{cm}^{-2}$ , 脱脂异常时磷化膜开路电位为  $-1.10 \text{ V}$ , 自腐蚀电流密度为  $6.31 \times 10^{-5} \text{ A} \cdot \text{cm}^{-2}$ , 说明脱脂异常时的磷化膜容易发生腐蚀, 异常的磷化膜腐蚀速率会比正常的磷化膜腐蚀速率快, 因此脱脂不良时获得的磷化膜耐蚀性能差, 易腐蚀。

Fig.6 Open circuit potential, impedance and polarization curves of phosphating films in 3.5%NaCl solution under different degreasing conditions: a) open circuit potential; b) impedance; c) polarization curve

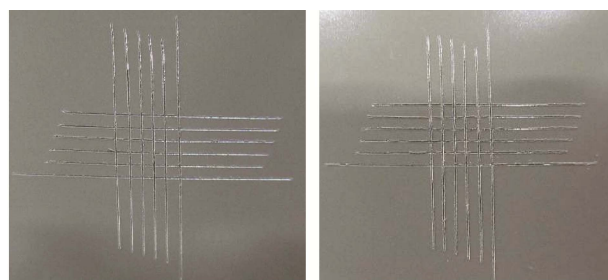
图7 电泳漆膜划格实验

a 脱脂不良时电泳漆膜划格实验 b 脱脂正常时电泳漆膜划格实验

按照《ISO 2409:2020 Paints and varnishes-Cross-cut test》国际标准进行电泳漆膜的划格实验,结果如图7所示。根据标准0~5级的评级分级,脱脂不良和脱脂正常时,划格处的切割边缘完全平滑,网格内没有漆膜剥落,评级均为0级,这说明钢板在一定程度脱脂不良条件下,对电泳漆膜划格附着力的影响较小。

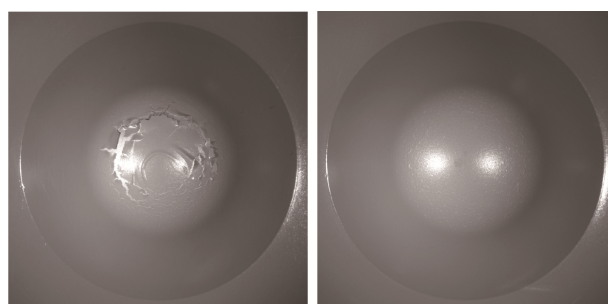
图8 不同脱脂条件下的杯突实验结果

如图8所示,当杯突高度为6 mm时,脱脂不良电泳板漆膜发生破裂,而脱脂正常时,杯突6 mm高度时,漆膜完整未破裂,说明磷化膜异常会导致电泳板的杯突性能下降,同时也说明漆膜与基板的附着力发生下降。

a 脱脂不良时电泳漆膜杯突实验 b 脱脂正常时电泳漆膜杯突实验

Fig.8 Results of cup process experiment under different degreasing conditions: a) poor degreasing; b) normal degreasing

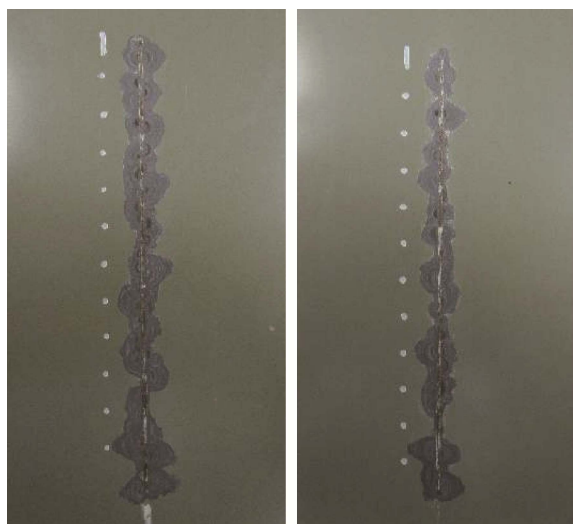
图 9 不同脱脂条件下的电泳板耐蚀结果

电泳板耐蚀性能一般采用加速腐蚀实验进行评估,结果表明脱脂不良时,电泳板单边扩蚀宽度为3.9 mm;脱脂正常时,电泳板单边扩蚀宽度为2.4 mm,如图9所示。出现差别的原因是脱脂不良引起磷化膜重低,微观形貌异常,导致其磷化膜本身耐蚀性能下降、电泳漆膜附着力下降,在膜下腐蚀过程中,漆

a 脱脂不良时电泳板耐蚀结果 b 脱脂正常时电泳板耐蚀结果

膜破坏处的磷化膜优先发生腐蚀,产生的腐蚀产物体积膨胀,撑破漆膜,造成划线处扩蚀宽度变大<sup>[27]</sup>。因此,脱脂不良会导致电泳板耐蚀性能明显下降,不利于车身防腐,缩短车身寿命,若涉及关键结构件,甚至会危害行车安全。

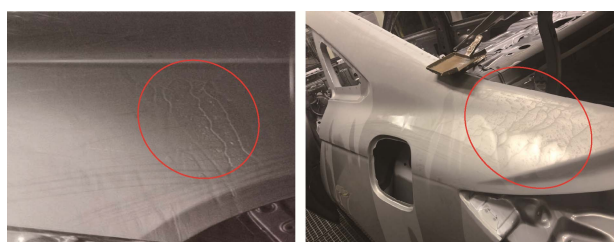
图 10 涂装线脱脂不良照片及磷化膜外观

在涂装产线生产过程中,一旦发生脱脂不良的现象,如图 10a 红色圈内所示,就会影响到车身磷化膜外观,出现明暗相间的花斑,如图 10b 红色圈内所示。出现此类问题时,若继续进行电泳及后续喷漆,车身耐蚀性能难以保障,需要对车身花斑处打磨处理,重新进行前处理,确保车身电泳后的耐蚀性能。同时需要反查脱脂工艺是否出现不合理变动以及材料涂油状态,确保脱脂正常,避免出现磷化膜花斑问题。

a 涂装线脱脂工艺处镀锌板脱脂不良照片 b 脱脂不良时镀锌板磷化膜外观照片

Fig.10 Photos of poor degreasing of painting line and phosphating film appearance: a) photos of poor degreasing of galvanized sheet in degreasing process of painting line; b) photos of phosphating film appearance of galvanized sheet under poor degreasing
